HOME INSPECTION REPORT

123 Any Street

Description of property inspected: Detached two story property.

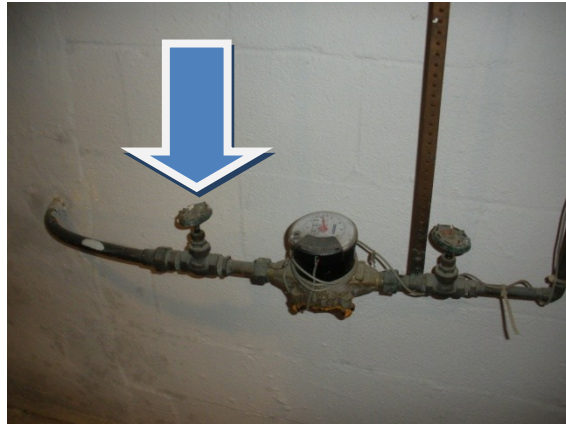
Main Water Shut-off Valve

Location: Basement

Type: Gate valve

Turn the gate valve clockwise until it stops.

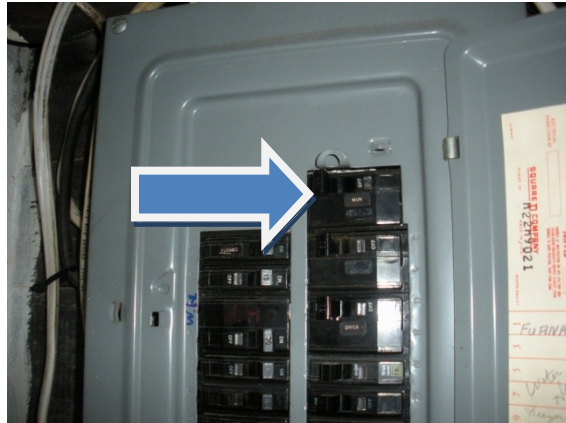
Main Electrical Disconnect

Location: Basement

Type: Circuit breaker

Push circuit breaker handle to the off position.

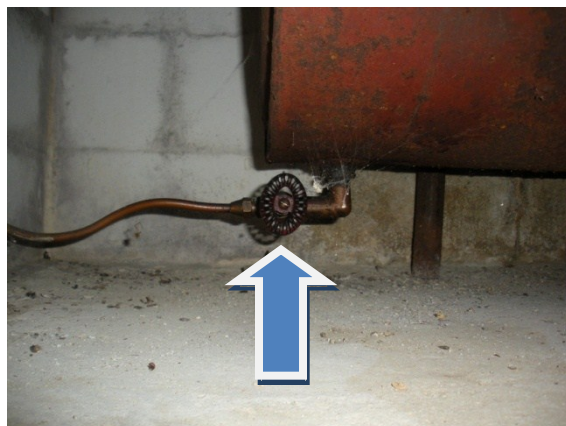
Main Fuel Source – Fuel Oil

Location: Basement

Type: Oil gate valve

Turn gate valve clockwise until it stops.

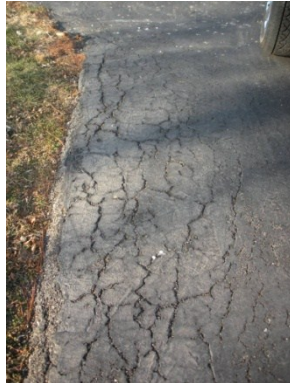
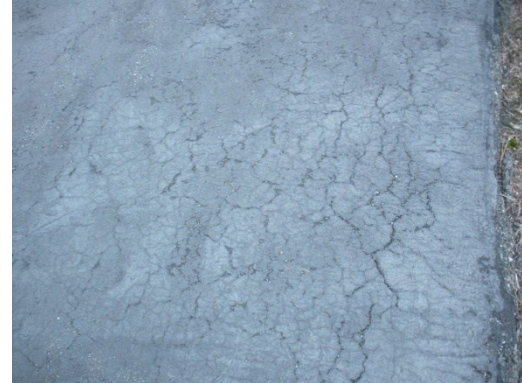
Driveway

The driveway was found with substantial cracking due to deferred maintenance. We recommend these cracks are professionally repaired to prevent further damage. The driveway should be resurfaced in the future.

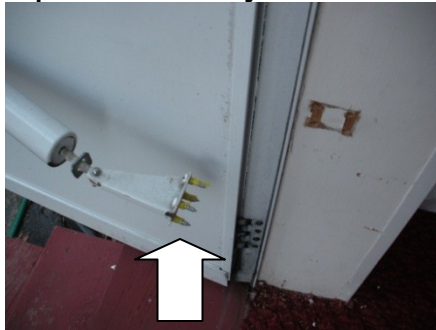
Exterior Doors **The side entry door was found with the closing mechanism in need of repair. Repair as necessary.**

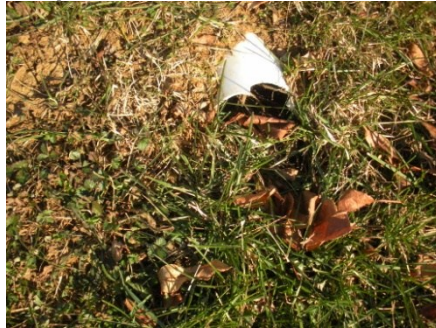
Buried downspout extension piping exit points were located and found clogged and in need of opening. The two right side downspout extension exit points should be cleared of debris and maintained open.

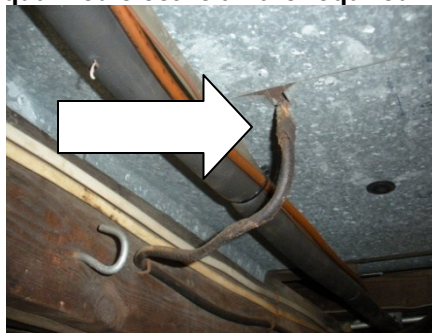
An electrical cable was observed located in the basement with open and exposed conductors installed through a return duct. The possibility of cutting through the conductors exist. Repairs by a qualified electrician are required.

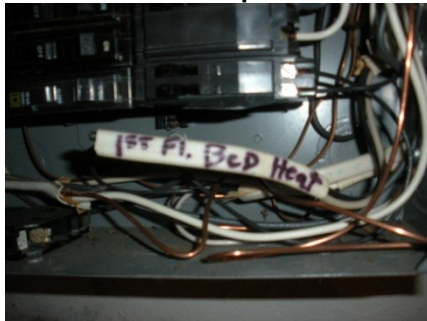
Heating System Type	Forced warm air system.
Fuel Source	Fuel oil with a 275 gallon fuel oil storage tank located in the basement.
Unit Venting	Natural vent to exterior through chimney.
Heat Distribution Type	Ducts
Combustion Air	Acceptable
Humidifier	None observed
Air Filters	Forced air furnaces should have the air filter checked and/or changed at the beginning of every heating/cooling season.
Supplemental Heat	The family room was observed with electric baseboard heating units with wall mounted thermostats. These heating units were found non-functional - repair as necessary. The electrical supply cable was found disconnected in the main electrical panel.
