Home Inspection Report

123 Any Street
Lititz PA 17543

Professional Home Inspection, LLC

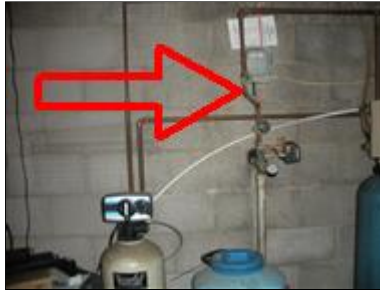
A. Main Water Shut-off Valve

Main Water Shut-off

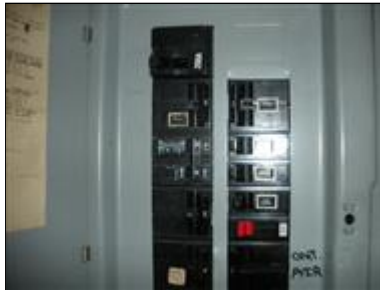
B. Main Electrical Disconnect

Main Electrical Shut-off

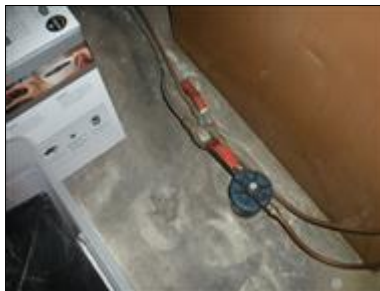
C. Main Fuel Oil Supply Shut Off Valve

Main Fuel Oil Sweep Valves

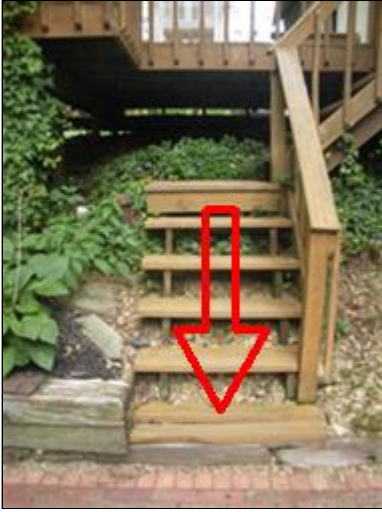
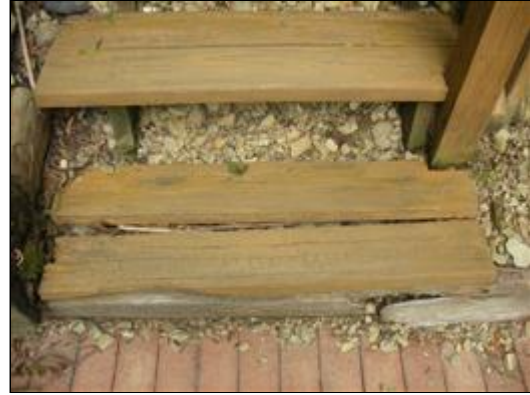
The wood steps from the deck to the patio were found with a damaged and deteriorated bottom step. Repair as necessary.

1. The wood steps from the deck to the patio were found with a damaged and deteriorated bottom step. Repair as necessary.

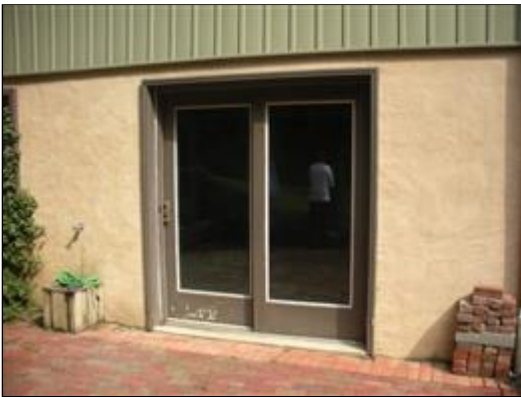
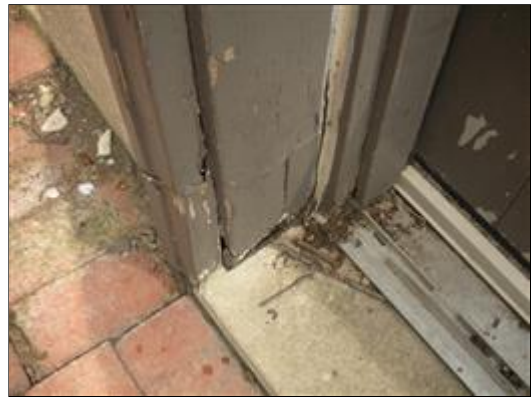
The lower rear exterior entry door at the patio was observed with signs of wood deterioration. Repair or replace the affected wood trim as necessary.

2. The lower rear exterior entry door at the patio was observed with signs of wood deterioration. Repair or replace the affected wood trim as necessary.

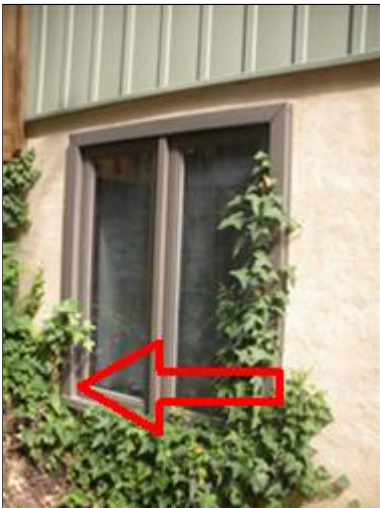
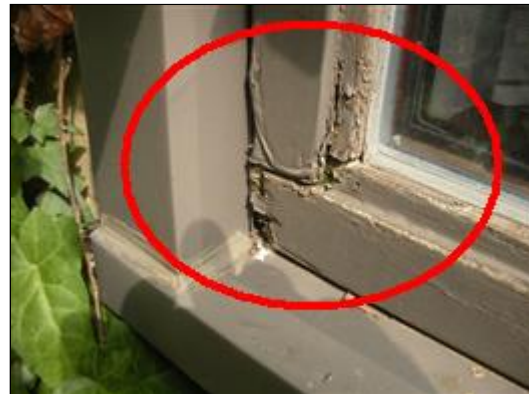
E. Exterior Windows

The exterior of the rear lower casement window located in the family room was found with wood damaged and rot. Replace the window as necessary by a qualified contractor.

1. The exterior of the rear lower casement window located in the family room was found with wood damaged and rot. Replace the window as necessary by a qualified contractor.

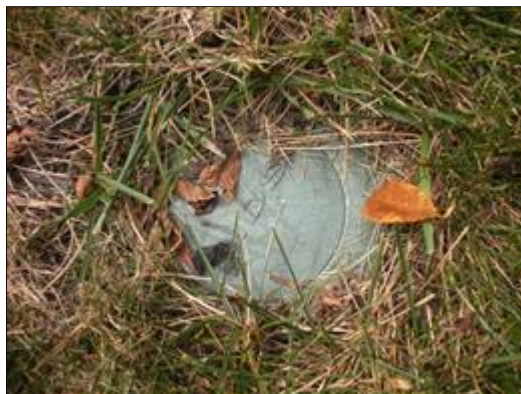
(2) *The buried downspout extension piping was observed with exit point pop-up emitters. These are devices connected to the end of the buried downspout extension pipe designed to allow rain water to discharge. They are generally installed with several inches of gravel beneath the emitter and a weep hole (a small hole located in the base of the pipe where it turns up) to allow drainage of any remaining water to prevent freezing in colder climates. It is important for the proper functionality of the pop-up emitter to keep the surrounding area clear of debris and overgrowth of grass or shrubbery so that the pop-up can fully open.*

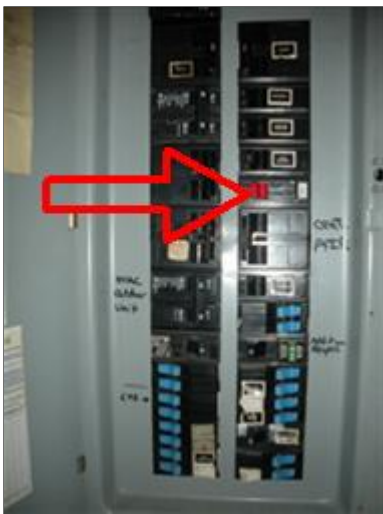
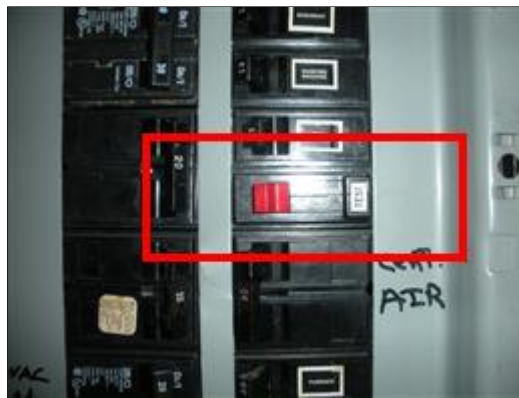
(1) **The GFCI circuit breaker located in the main electrical panel was found non-functional. This GFCI device would not trip to interrupt the flow of electrical power under test fault conditions. Replace this device - work should be performed by a qualified electrical contractor.**

2. (1) The GFCI circuit breaker located in the main electrical panel was found non-functional. This GFCI device would not trip to interrupt the flow of electrical power under test fault conditions. Replace this device - work should be performed by a qualified electrical contractor.
3. (2) Confirm proper GFCI protection of all other locations requiring GFCI protection upon completion of repairs.

(2) **Confirm proper GFCI protection of all other locations requiring GFCI protection upon completion of repairs.**

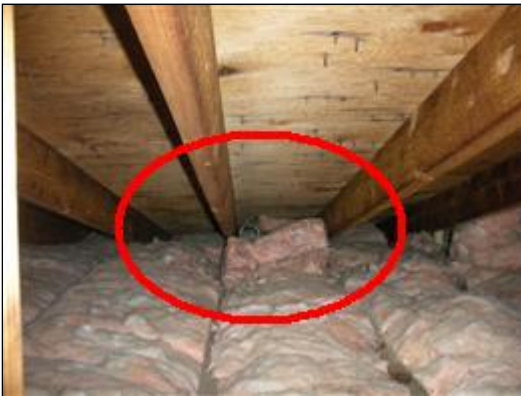
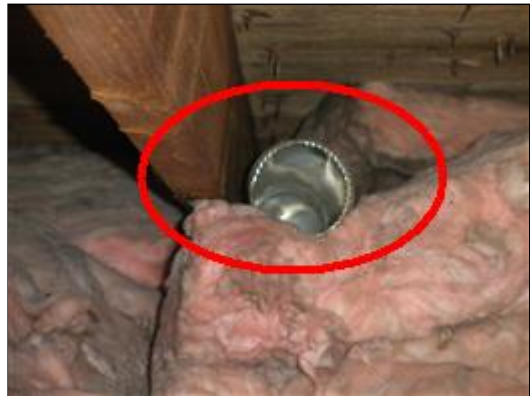
The bathroom exhaust fan vent terminates in the attic. It is recommended this exhaust fan vent terminates to the exterior of the property to assist in controlling humidity levels in the attic space.

4. The bathroom exhaust fan vent terminates in the attic. It is recommended this exhaust fan vent terminates to the exterior of the property to assist in controlling humidity levels in the attic space.

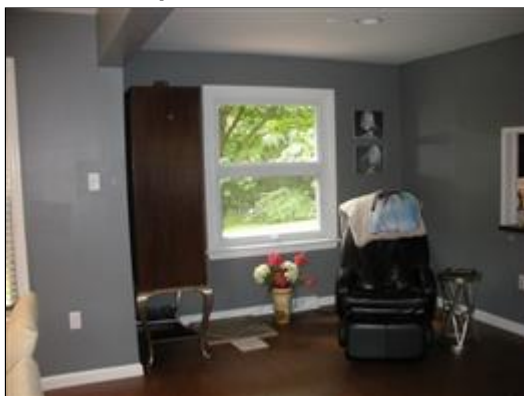
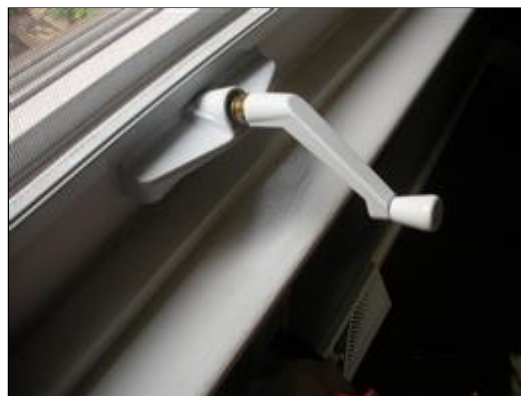
(1) **The rear casement located in the living room was found with damaged operator hardware. Repair by a qualified window repair technician.**

5. (1) The rear casement located in the living room was found with damaged operator hardware. Repair by a qualified window repair technician.

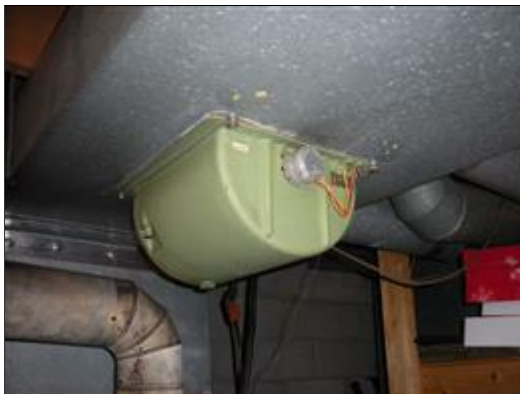
A humidifier was observed. We recommend the removal of this humidifier. Older style humidifiers hold water in a reservoir causing potential mildew and mold build up.

1. **A humidifier was observed. We recommend the removal of this humidifier. Older style humidifiers hold water in a reservoir causing potential mildew and mold build up.**

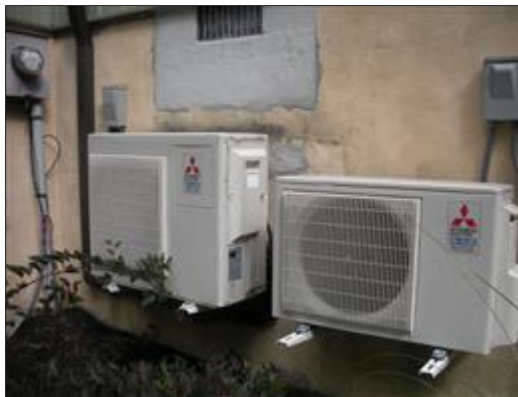
Two mini split ductless heating and cooling systems were observed. One unit is equipped with two indoor units, one unit is equipped with one indoor unit.
